Optical *in-situ* analysis of the cavitation damage on technical alloys under repeated single bubbles

Doktors der Ingenieurwissenschaften

genehmigte Dissertation

Jonas Kühlmann

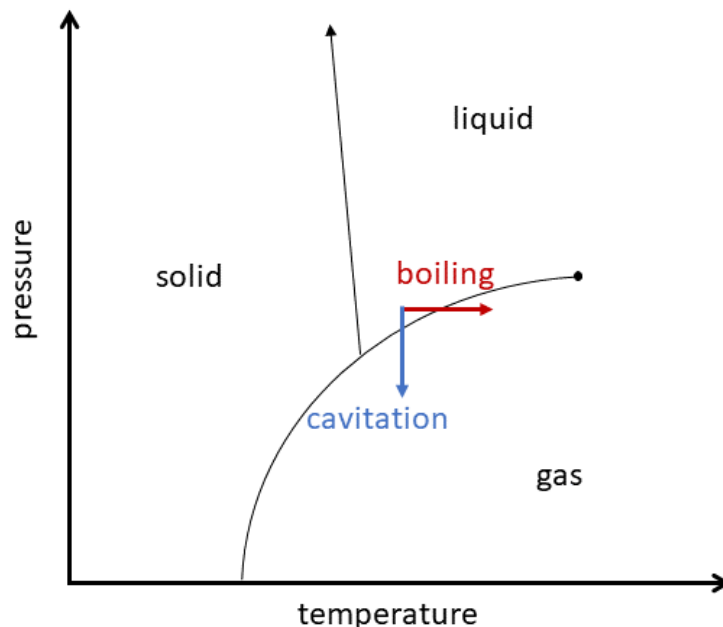
Fig. 1 Schematic phase diagram for water (adapted from [13]).

Cavitation, i.e., phase change due to the ambient pressure falling below the liquid's saturation vapor pressure, is distinct from the transition to the gas phase by boiling which is caused by a rise of temperature [13]. Fig. 1 shows a schematic phase diagram of water. A given set of pressure and temperature is assigned one of three states of matter – solid, liquid and gaseous. The lines in the graph indicate a transition between these states [13]. The point where all lines intersect is called the triple point in which all three states are present. The end point of the gas-liquid intersection line is the critical point at which liquid and gas phase cannot be distinguished. The arrow where the line separating solid and liquid ends indicates that this line does not end at a critical point and both phases can still be distinguished. Cavitation can be represented with a vertical line between liquid and gas phase (isochoric) while boiling would be a horizontal line (isobaric) [13].

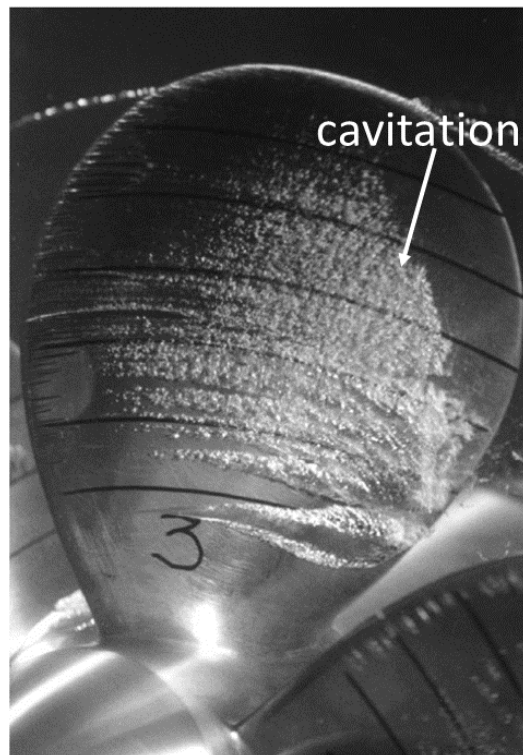
Fig. 2 Cavitation occurring near a ship propeller (adapted from [15]).

The origin of cavitation bubbles in the increase in velocity of the fluid means that they are typically unstable and collapse when the velocity decreases and bubbles, therefore, reach areas of higher pressure. Fig. 2 shows cavitation occurring due an acceleration of the fluid near a rotating ship propeller. The cavitation occurring in this example is also limited to an area close to the blade of the propeller which means most bubbles collapse before leaving the vicinity of the blade. The collapse of these bubbles can then lead to cavitation damage and cavitation erosion, which is discussed in the next section.

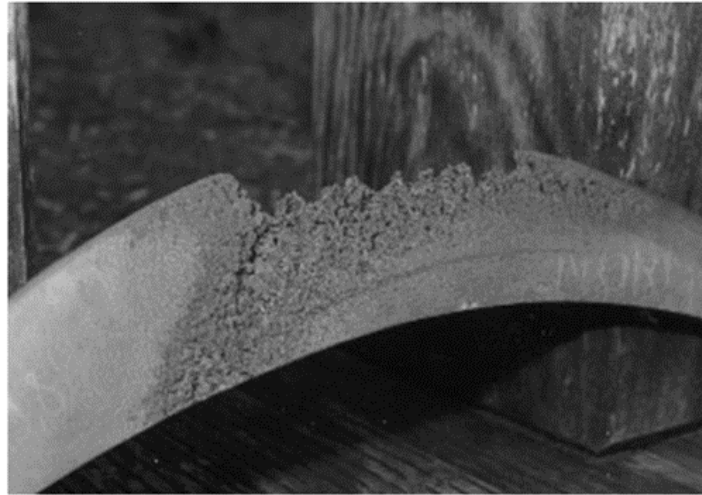
Fig. 3 End stage of cavitation erosion of a ship propeller (adapted from [15]).

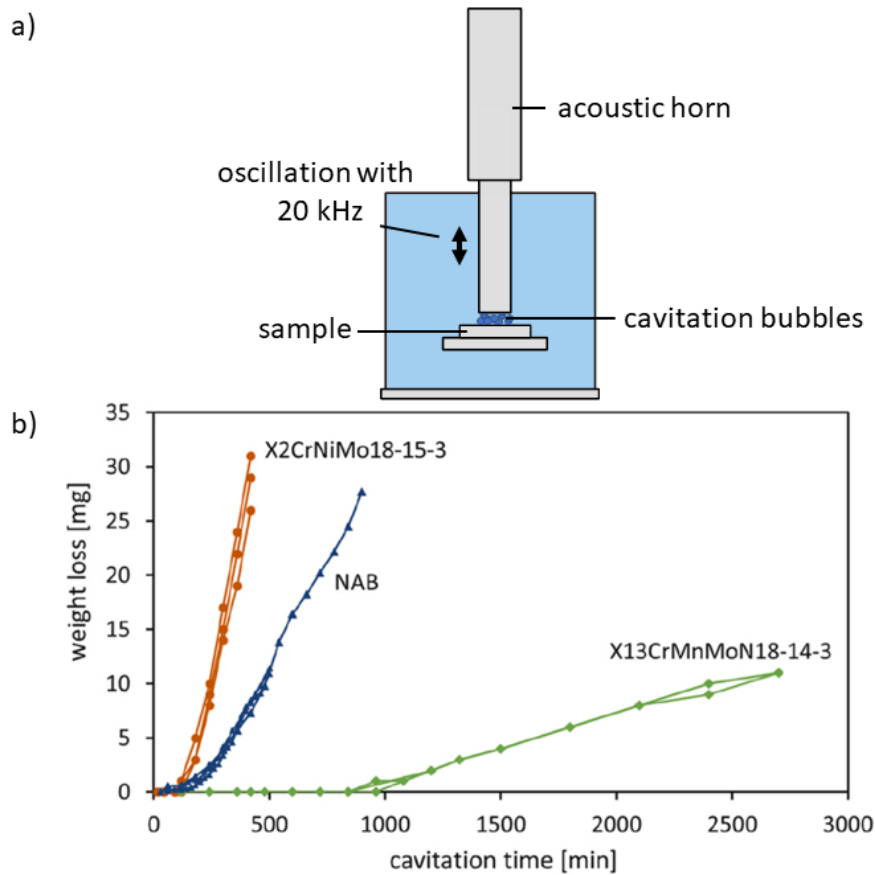
Fig. 4 a) Schematic of an acoustic cavitation experiment and b) data on weight loss over time under acoustic cavitation (adapted from [3]).

In addition to erosion of ship propellers, cavitation erosion can occur in applications such as nozzles, pumps, and turbomachinery [4, 5, 15, 17, 18]. Prevention of cavitation erosion is approached from different directions. In applications, there is a desire to first minimize the extent to which cavitation occurs in general as well as the distance from the solid surface near that it does [15]. Also, it is possible to select the material properties in such a way that there is a high resistance against cavitation erosion [19]. Cavitation resistance of technical alloys is typically tested according to the “American Society for Testing and Materials” (ASTM) standard G32 [3, 20, 21]. Fig. 4a shows a schematic of an experiment in which an oscillating sonotrode induces bubbles called acoustic cavitation. ASTM G32 looks at the material loss that occurs over a certain time period when the material is exposed to acoustic cavitation [21]. An example of data acquired in such experiments is shown in Fig. 4b.

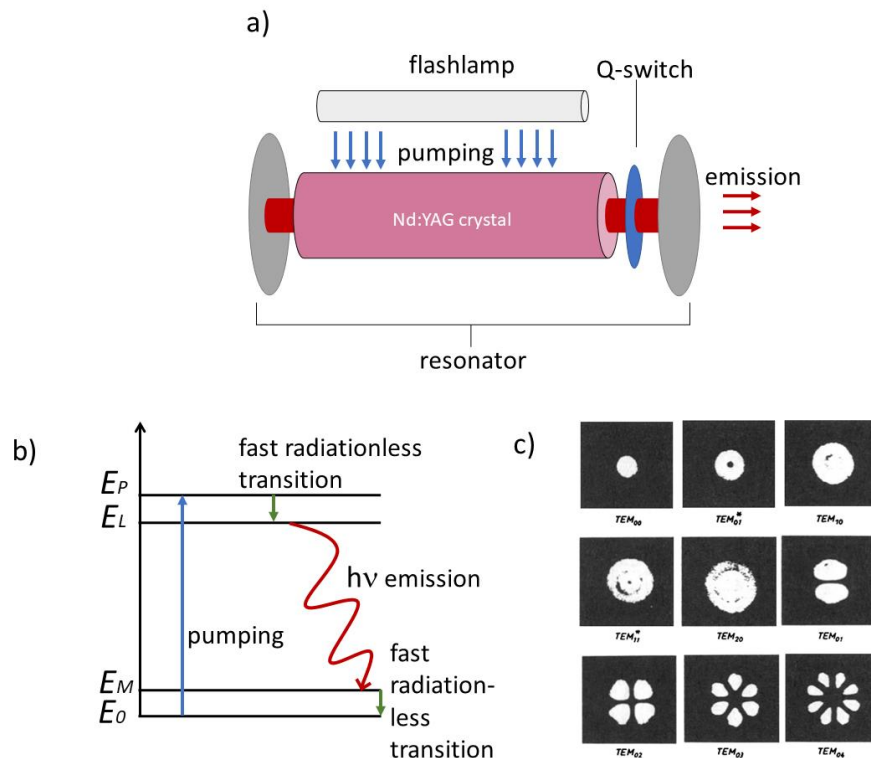
Fig. 10 a) Arrangement of laser components b) Schematic of states of a four-level laser c) TEM modes of a laser with round mirrors (adapted form [34]).

The term 'laser' is an acronym for 'light amplification by stimulated emission of radiation', which describes the process used to create monochromatic, coherent high-power light “beams”. Fig. 10a shows a typical arrangement of essential laser components. In solid-state lasers, an ion-doped glass or crystal is optically pumped by a flash lamp. The laser-active material is placed between mirrors where light oscillates during the amplification. The amplification is possible due to a specific state structure of the electrons in the optically active dopant, shown schematically

in Fig. 10b. The pumping process excites electrons from the ground state E_0 to the state E_p . This state quickly relaxes to the state E_L without emitting radiation. Sufficiently high pumping rates cause population inversion, in which there are more electrons in the state E_L than in the ground state E_0 . By relaxation to E_M , this state emits the laser wavelength. However, due to the population inversion, the dominant relaxation mechanism is by stimulated emission which causes the amplification of coherent radiation during the oscillation of the light in the laser [34].

In a laser cavity, light can oscillate in different resonant modes. Most relevant here are the transverse electromagnetic (TEM) modes. In which modes the light oscillates depends in particular on the geometry (distance and type of mirrors) of the resonator as well as the fine adjustment of the laser, but is also influenced by the laser temperature, for example [34]. The spatial combination of the TEM modes generates the transverse “beam profile” of the laser. Fig. 10c shows modes that can occur in a laser with round mirrors. The lowest order mode is Gaussian, while higher order modes are more complex. In particular, their diameter also increases, and the beam intensity is unevenly distributed. The beam profile can be a combination of multiple modes and in pulsed lasers, the beam profile can fluctuate from pulse to pulse, which must be taken into account in experiments.

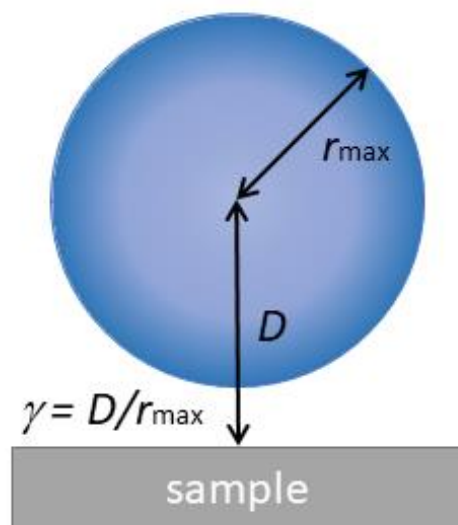
Fig. 15 Stand-off distance γ .

Many studies investigated the fluid dynamics of collapsing bubbles [28, 42, 50–53]. Other works studied the effect of such individual bubbles on a nearby solid surfaces [9–12, 44, 54, 55]. The experiments investigating effects on the surface are discussed in detail in Section 3.3. When the collapse of a single bubble occurs close to the solid boundary, the dynamics of the bubble dramatically deviate from the spherical oscillation described in Section 2.1.3. The overall shape of the collapse that occurs depends mainly on the stand-off distance γ , which is defined as the distance D of the bubble center from the solid boundary divided by maximum bubble radius r_{max} (Fig. 15).

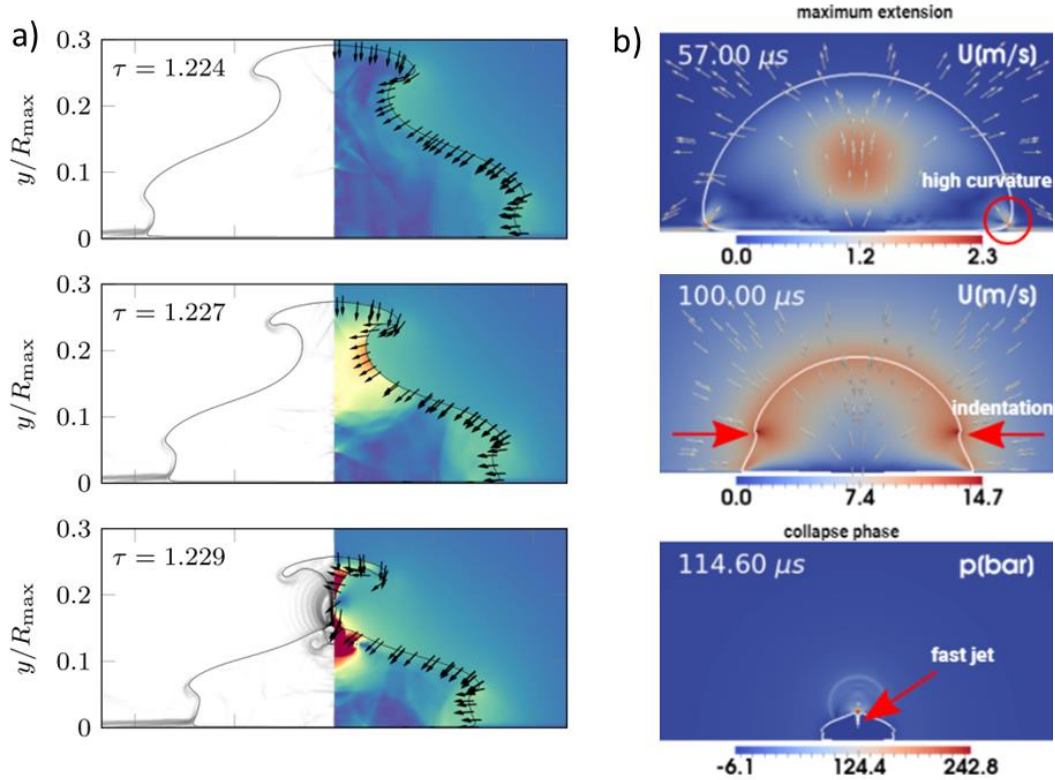
Fig. 17 Selected pictures from current single-bubble simulations near boundaries at different stages of the bubble collapse a) The right side of the image showing scaled numerical schlieren image and the right side the normalized velocity amplitude (adapted from [68]) b) Images show details of the flow (grey arrows) and color gives the pressure in bar (adapted from [70]).

Even though considerable progress has been made in recent years in the field of single-bubble simulation, three-dimensional simulations are quite rare, especially when it comes to bubbles near boundaries. A three-dimensional simulation of Sagar and el Moctar [72] shows a non-axisymmetric collapse of a spherical bubble.

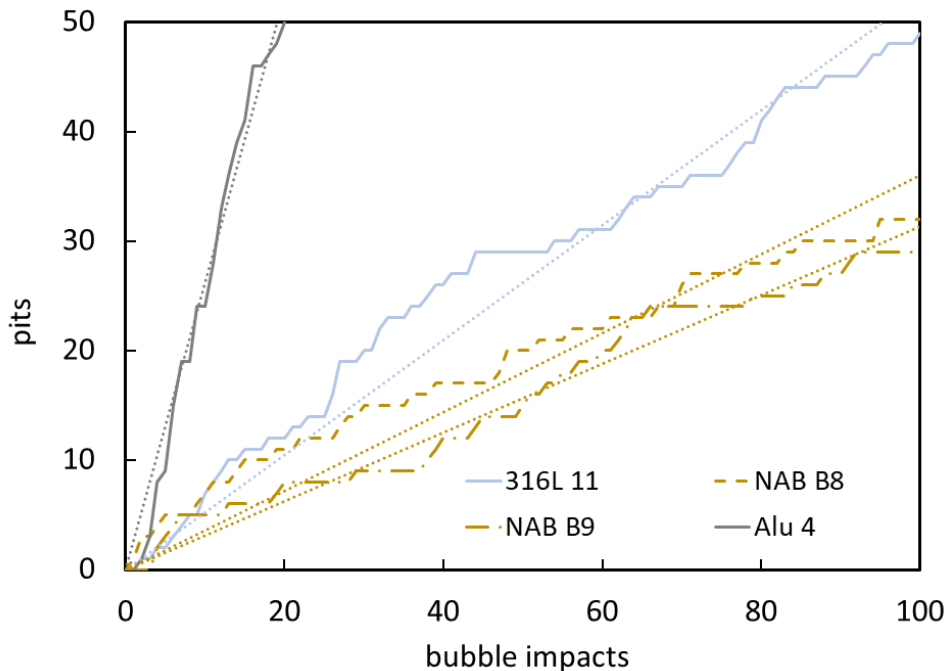
Fig. 29 Pit count per bubble and linear fit of the pit count. For NAB, two samples were considered, as indicated in the legend after the material designation.

To obtain a quantitative measure of early damage progression, we counted the pits after each bubble within a series. Pit counting was done by visual inspection, and the size and shape of the pit was disregarded. Fig. 29 shows the result for series

of 100 successive bubbles for the three materials, with two samples for NAB. Between zero and six additional pits are found after a single collapse. The slope of this pit-count graph, approximated here as a linear fit through the origin to each data series, is then the series-mean pitting rate. The parameters of these experiments and the pitting rate are listed in Tab. 1. About 50 pits could be counted on a single sample before it became hard to distinguish overlapping pits. Beginning pit overlap may also be the reason why the slope of all traces decreases towards higher pit counts. The pitting rates have the same order among the materials as the corresponding material hardness, as does the maximum number of pits after a single bubble collapse. After one collapse, 0-2 pits occurred on NAB, 0-3 on 316L, and 0-6 on aluminum. It is also remarkable that on one hand, even a soft material like aluminum did not show damage after every collapsing bubble. On the other hand, sample B8 from the hard NAB had a pit after the very first bubble. The two NAB samples differ slightly in their bubble parameters and in the pit count progression, but in this initial demonstration it is not clear if the difference is significant.

Tab. 1 Parameters of the experiments and results of the pit counting presented in Fig. 29. The hardness was not measured on the samples used here, but on other samples from the same material and with the same processing.

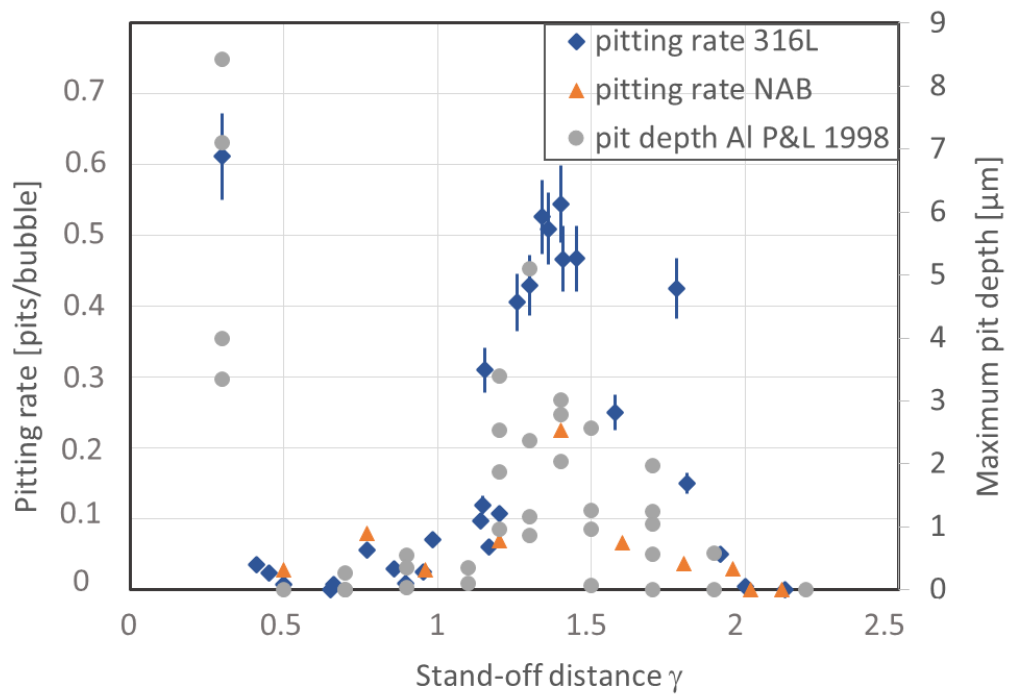
The influence of γ on the pitting rate is shown in Fig. 49b. The radius of the bubbles was $r = 1.3 \pm 0.2$ mm for 316L. The variation in radius is included in the error, which from Fig. 49a is estimated to be about 10%. At $\gamma = 2.15$, 500 bubbles did not generate a pit, i.e., the pitting rate is less than 0.004 pits per bubble, which we considered essentially zero for current purposes. Towards small stand-off-distances, the pitting rate increases and peaks at about $\gamma = 1.4$, decreasing again

with decreasing stand-off distance to less than 0.1 pits/bubble at $\gamma = 1$. For $0.4 < \gamma < 1$ the pitting rate remains below 0.7 pits/bubble. The steep increase for $\gamma = 0.3$ to over 0.6 pits/bubble again points to a different mechanism at work for these small standoff distances [81]. An obvious outlier in the otherwise relatively smooth relation of pitting rate vs. standoff distance is $\gamma = 1.75$, with 0.425 pits/bubble. This might be explained by the sudden change in area onto which the bubble collapses at $\gamma = 1.75$. As the stand-off distance is increased from 1.55 to 1.75, the area on the sample that the bubble collapses onto significantly changes, its shape being a large ring for the former but a solid circle for the latter (Fig. 40 f and g). For $\gamma > 1.75$ we suggest that with increasing γ less and less energy is reaching the sample surface and an SCA creating a load sufficient for plastic deformation becomes less likely. In addition to the data from 316L, Fig. 49b shows the pitting rate on NAB. The general trend corresponds to that on 316L, with the absolute pitting rate being lower for most γ . For $\gamma = 0.5$ and $\gamma = 0.76$ the pitting rate is slightly higher than on 316L. Most likely this is because the bubble radius was about 10% larger in these two measurements. The upper boundary for pit occurrence was not significantly different on NAB.

P&L 1998 report two series of measurements on aluminum in the range $0.3 < \gamma < 2.15$, examining the depth of the pits [11] (Figures 20 there). The data of this measurement series is also plotted in Fig. 49b. Despite the different material, that metric yields a graph that is similar to our pitting-rate data on 316L and NAB. This similarity may imply that both the depth of the pits and the probability of a pitting event are proportional to the load on the surface. In contrast to the pitting rate that is the average over multiple bubbles on the same sample, the pit depth data, each stemming from a single bubble, scatters more. The upper boundary of detectable pit depth in P&L 1998 on aluminum was similar to the boundary for our pitting rate on 316L and NAB. Recently, also in laser single bubble experiments, Abedini et al. estimated the damage to the oxidic surface layer on an aluminum sample from time integration of the measured transient electric current [99]. Consistent with the trends here, they found that the greatest damage occurred at $\gamma = 0.3$ and $\gamma = 1.4$.

Fig. 49 a) Pitting rate versus radius at $\gamma = 1.40 \pm 0.05$. The data at $r = 0.84$ mm was taken at a slightly larger stand-off distance, $\gamma = 1.48$, b) pitting rate vs. γ at $r = 1.3 \pm 0.2$ mm on 316L and NAB, pit depth on aluminum from P&L 1998.

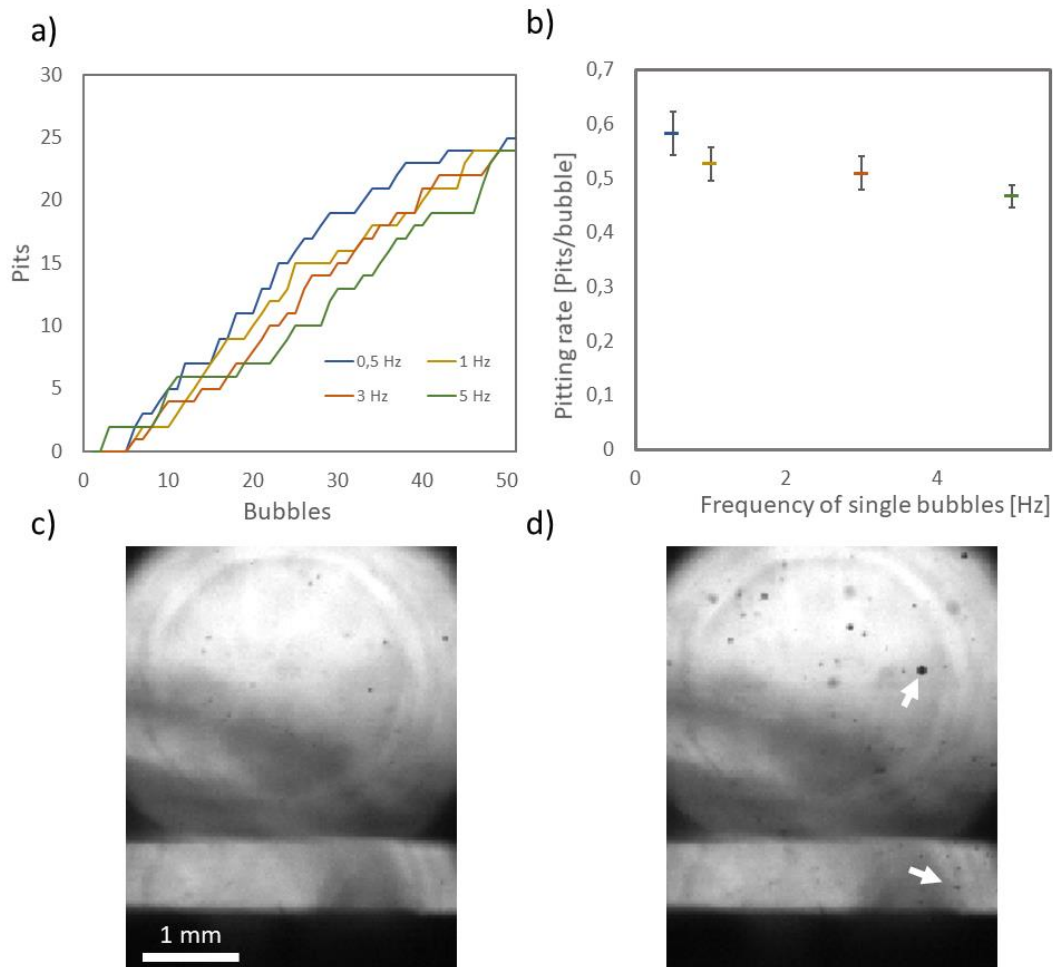
Fig. 56a shows the pit count at four different bubble repetition rates. After 50 bubbles, there are 25 or 26 pits at all repetition rates. Fig. 56b shows the pitting rate calculated from Fig. 56a. The errors bars represent the uncertainty of the linear fit. All four measurements are quite close. At the highest repetition rate of 5 Hz, the rate slightly decreases. However, the average bubble radius was also slightly lower for this measurement. This may be due to the fact that more dissolved gas bubbles refract part of the laser beam which can result in smaller bubbles. We conclude

These measurements allow further conclusions regarding the influence of the experimental conditions on pit formation. Fig. 56c and d show example images of the sample in water a few microseconds before the plasma breakdown at a repetition rate of 1 Hz and at 3 Hz. In the latter case, more dissolved gas bubbles are seen in the bulk liquid and also directly on the surface (white arrows) than in the former case. However, the pitting rate is the same. Thus, more dissolved-gas bubbles, which is the main effect of higher frequencies, do not seem to have a significant effect on pitting.

Two aspects can be inferred from the dissolved-gas bubbles in the fluid and the lack of change in pitting rate over the repetition-rate variation. First, these bubbles did not move in the high-speed sequences, indicating that there is no significant flow left in the fluid from the previous bubble. Second, pitting in connection with bubbles on the surface excited by a shock wave – as described in Section 5.3.4 – is not a dominant mechanism in our experiment.

Fig. 56 a) Pit count for 50 bubbles at different frequencies b) Repetition rates dependence of the pitting rate c), d) Liquid in the region where the bubble is induced just before the plasma breakdown at a bubble repetition rate of 1 Hz and 3 Hz, respectively. Arrows mark two of many gas bubbles in the liquid.

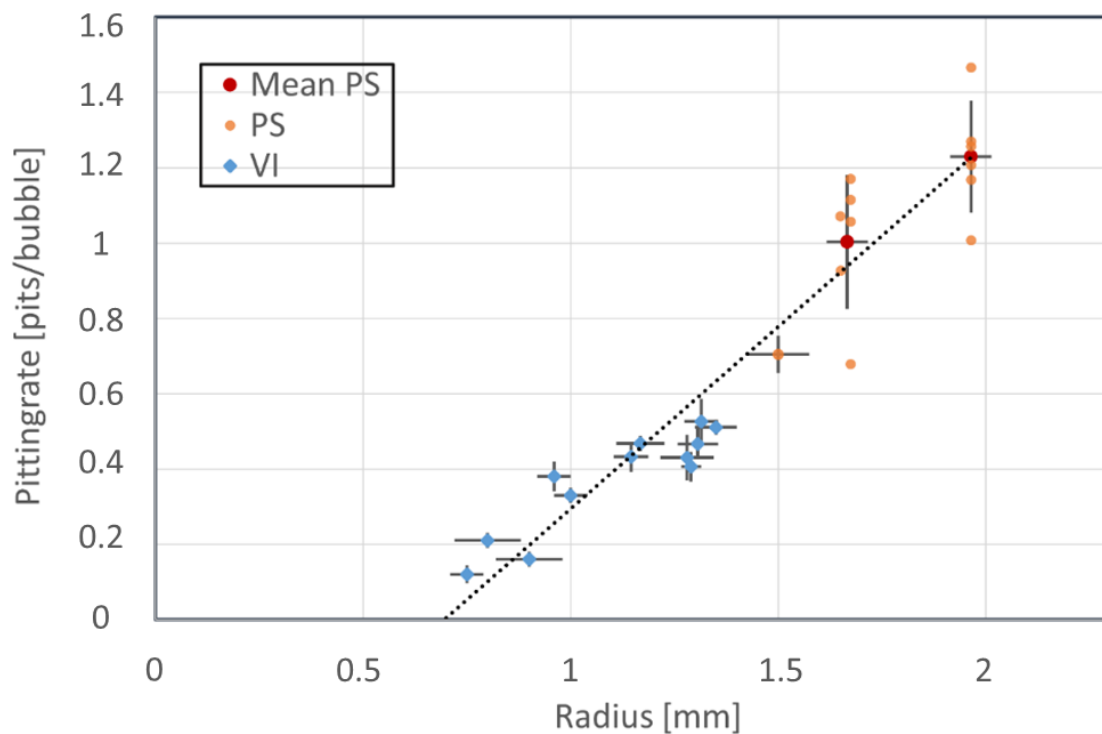
Fig. 60 Pitting rate versus radius at $\gamma = 1.35 \pm 0.05$. Data from Fig. 49a (blue, [60]) extended with data from the AI project (orange) (adapted from [100]).

Fig. 60 shows data from Fig. 49a (blue, [60]) which is extended with data from the AI project (orange) stemming from experiments with larger radii. In contrast to the measurements presented above, fewer parameters varied here, but more measurements were carried out for each combination of γ and r . This makes it easier to estimate the dispersion of the pitting rate and thus the significance of the

values. For this purpose, the figure also contains mean values and standard deviation at points $r = 1.65$ and $r = 1.95$. The pitting rate represented by the blue points (VI) was also compared to the AI evaluation and showed good agreement. A more detailed discussion is beyond the scope of this section but can be found in [100].

Overall, the linear trend found for smaller radii is seen to continue for larger radii. However, the pitting rate fluctuates significantly more with constant experimental parameters than for the lower radii. Also, the possible number of pits found after a single-bubble collapse was up to five pits on 316L (it was three for smaller radii). This might explain the larger standard deviation.
